High-precision wall thickness monitoring in nuclear power plant

In-service, high-temperature, high-precision wall loss monitoring of steam piping circuit in a nuclear power plant

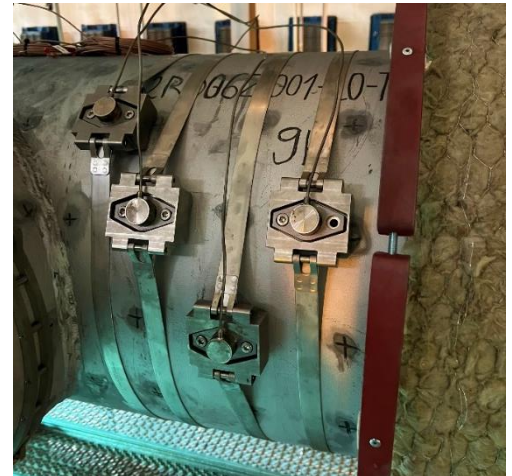
- 16 x HotSense 380 sensors were deployed around each T-junction to provide a sensor which could operate continuously above 230 °C and provide a stable and reliable thickness measurement.
- The HotSense strap deployment system allowed for fast installation during the limited shutdown and offered flexibility to place sensors in the expected pattern to detect wall loss.
- Initially, all sensors were connected to Measurement Hubs for manual data collection from a lower platform using a GE flaw detector.
- The CALIPERAY automated monitoring system was inspected by the local electrical engineering team and the radio output found to be of no concern to the safe operation of the site.
- The Measurement Hub was subsequently upgraded to a fully automated CALIPERAY WirelessHART node with Field Deployment Logging Kit (FDLK) for simple implementation and data collection.

- The full system solution was successfully deployed within 2 months from initial enquiry to meet the scheduled turnaround.
- All sensors were successfully installed within the first day. The NPP inspection team had live, continuous, reliable wall thickness data within 24 hours of the equipment being delivered on site.
- Transferring from a rapid deployment, non-wireless, Measurement Hub solution to the fully WirelessHART CALIPERAY system provided a path to monitoring that met the clients time scales and security and
