Erosion Monitoring of Buried Tailing Lines

In-service, erosion monitoring of buried pipeline infrastructure of a mining operation

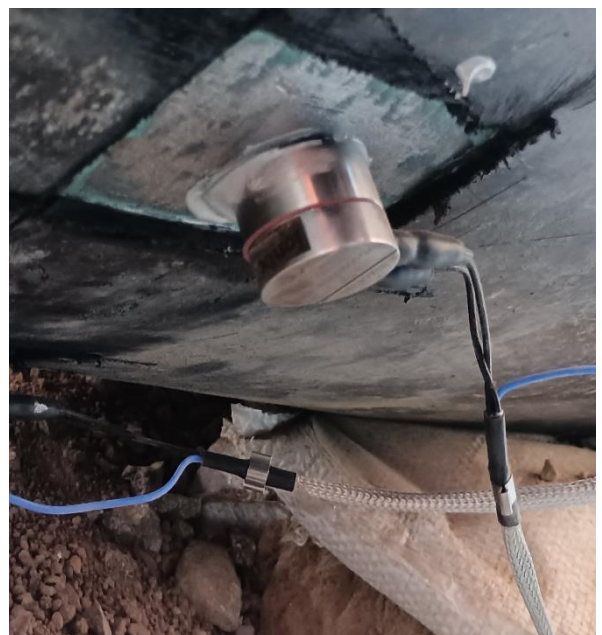
- Monitoring of erosion events was required to link to process events up-stream to enact preventative measures and schedule repair.
- The expense in exposing and inspecting the buried sections of the tailing lines meant that traditional, hands-on inspection solutions were not viable.
- Robust sensors were required to be buried and accessed manually by survey teams, without the need to expose the tailing lines themselves.

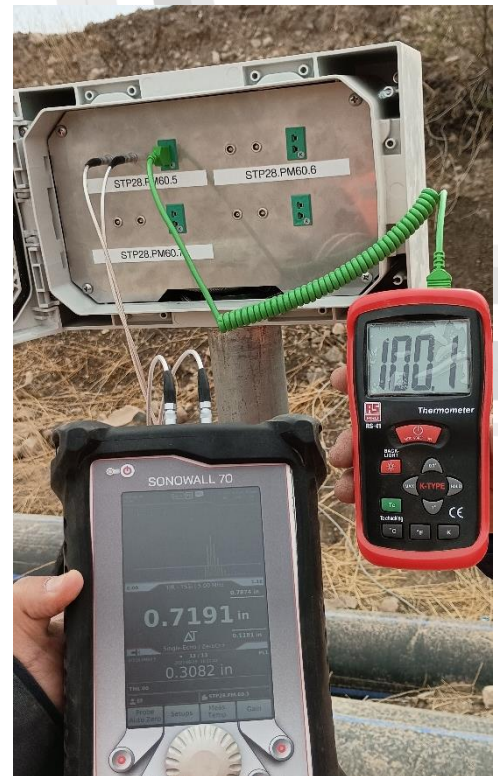
- 38 HotSense™ DE sensors were installed using integrated high-strength magnetic fixings, along with epoxy coupling, for a robust and low-profile deployment.
- HotSense™ DE sensors were chosen due to their low-cost, high-accuracy and precision measurements to allow for reliable erosion trending.
- HotSense™ sensors were paired with Ionix Measurement Hubs at ~100m intervals to allow quick and simple measurements to be collected from easy-to-access connection points. The data from the Measurement Hubs was collected using commercially available thickness gauges.
- The sensors were composite wrapped for added protection and electrical isolation from the ground.

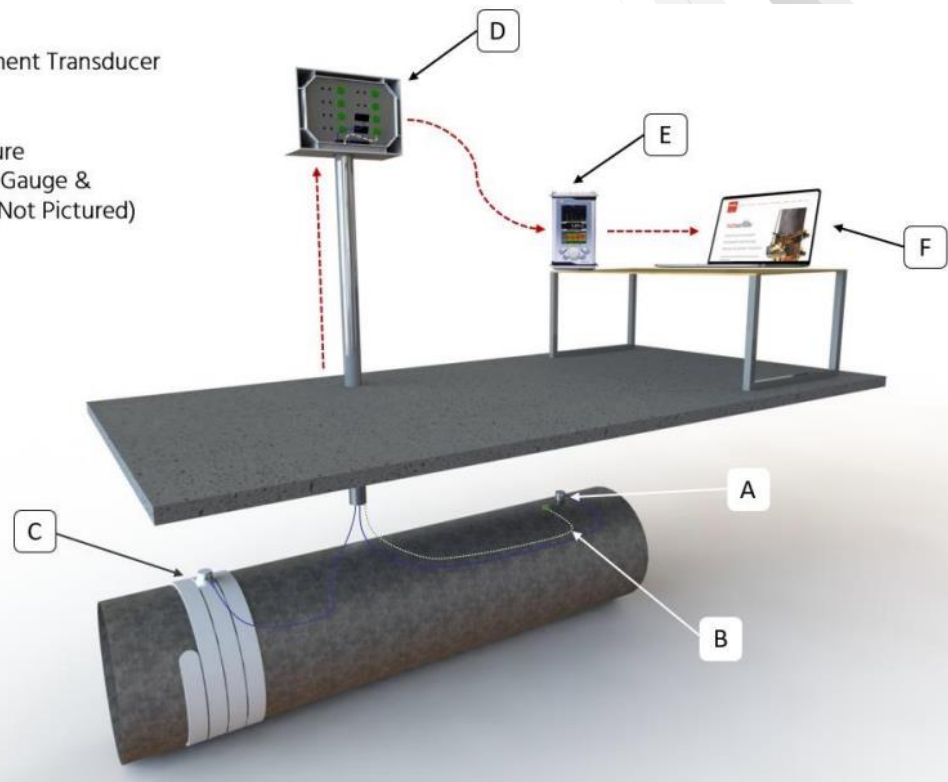
A – HotSense Dual Element Transducer
B – Thermocouple
C – Probe Sealing Kit
D – Pole Mount Enclosure
E – Sonowall Thickness Gauge & Thermocouple Reader (Not Pictured)
F – Data transfer to PC
