Energy from Waste Wall Loss Monitoring

In-service, high- temperature high-precision corrosion monitoring of critical assets in UK Energy Recovery Facility (ERF)

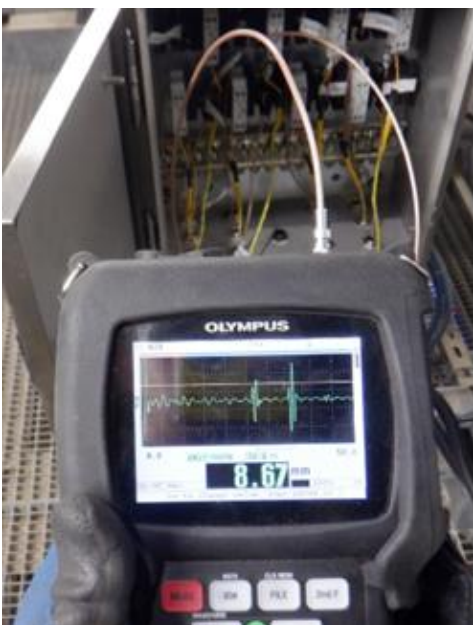
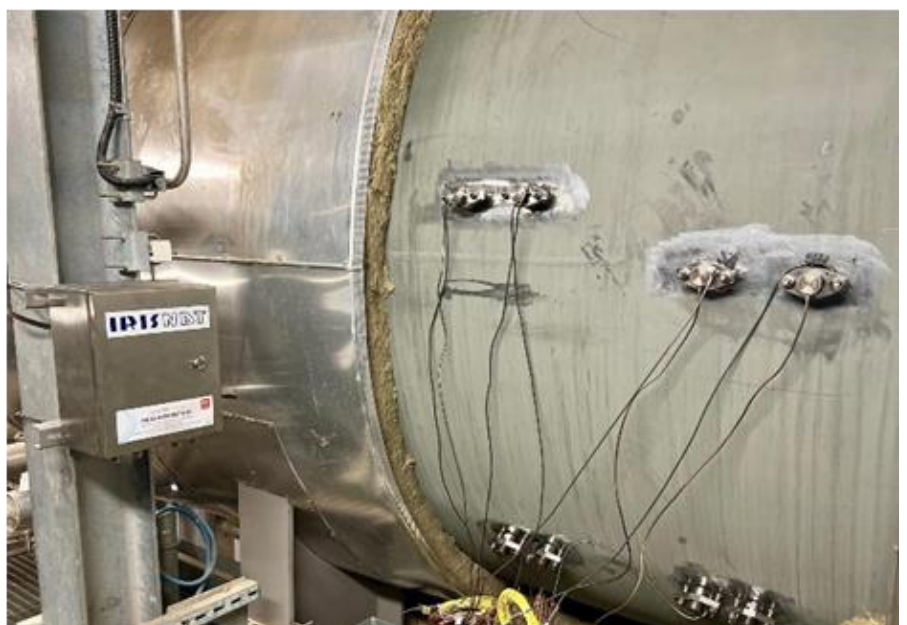
- The HotSense™ welded stud deployment system was utilised to deploy on various locations on the large diameter vessel. The HotSense™ welded stud deployment system was utilised to deploy on TML's across each vessel.

- HotSense™ sensors were connected to Ionix Measurement Hubs to allow quick and simple measurements to be collected from easy-to-access connection points to get started before upgrading to a wireless solution. The data from the Measurement Hubs was collected and verified using a commercially available thickness gauge.

- The solution was successfully deployed by IRISNDT during a small shut down window period, <48hrs.
- 16 sensors with thermocouples for accurate compensation were installed, under insulation, with Ionix Measurement Hubs.
- Following installation, stable, repeatable measurements are being collected with temperature compensation being applied by the gauge.
- Wall thickness data is now being collected frequently by inspection technicians whilst the plant is on-stream, prior to upgrading to an autonomous wireless solution.
- The cost of inspecting the asset has been reduced and the safety of the inspectors has been increased.
