Trending non-linear wall loss of petrochemical vessel

In-service, high-temperature corrosion monitoring of a critical vessel on a petrochemical plant

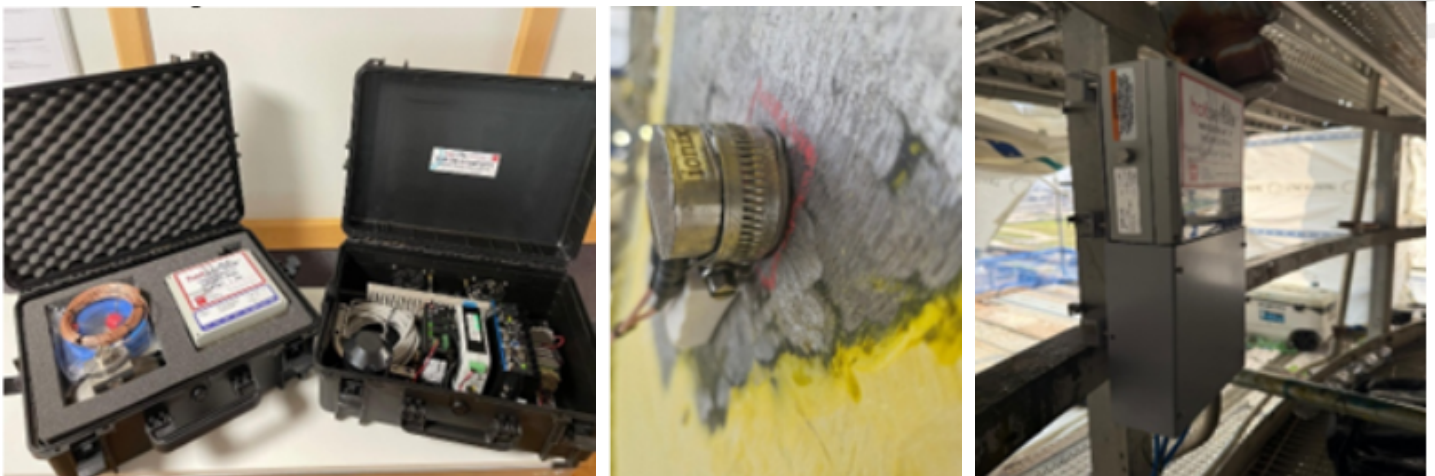
- HotSense DE sensors with an epoxy coupling solution were selected to withstand continuous operation up to 350°F while providing stable and reliable thickness measurements.
- The HotSense DE sensors were modified with additional mechanical support to ensure long-term reliability, as the installation location is inaccessible once deployed.
- Four CALIPERAY WirelessHART monitoring nodes were installed, each connected to three probes and equipped with an individual thermocouple to enable accurate temperature compensation.
- A HotSense Field Deployment Kit was deployed on site, consisting of a WirelessHART gateway and an industrial edge PC running the WAMP server to securely collect all monitoring data locally.
- A secure remote connection to the WAMP server was established, enabling off-site review, analysis, and export of monitoring data.

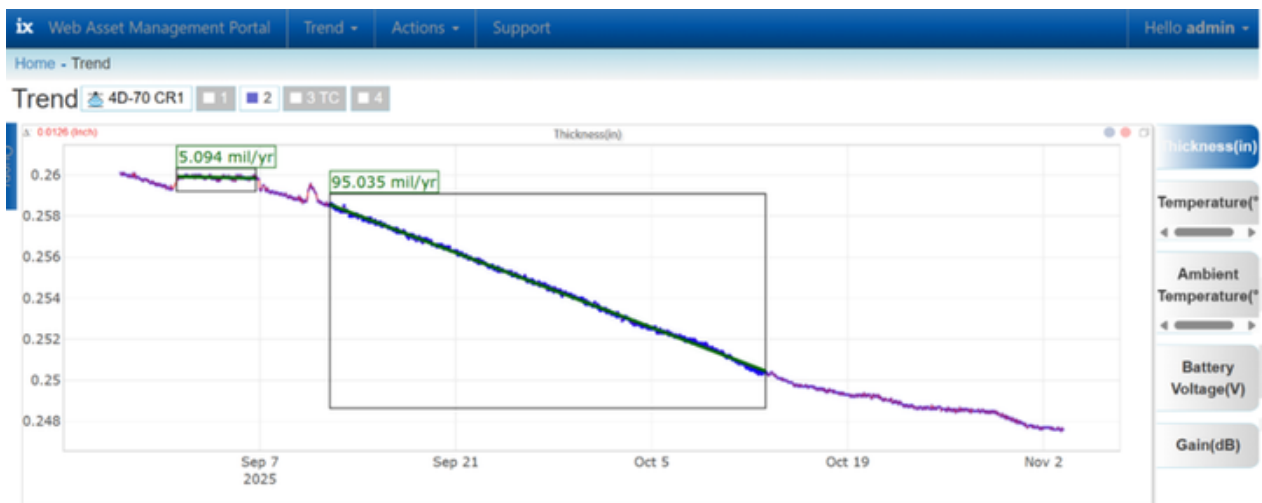
The full system solution was successfully deployed in 2 days during live plant operation, together with a full WirelessHART network system. System software has been installed, and data was made available at all the required control centres feeding the client's Plant Integrity Monitoring Systems.

Using HotSense™ installed with CALIPERAY monitoring nodes allowed for **automated, robust and reliable wall thickness measurements to be collected from live high temperature assets.**
