## High-temperature UT Inspection of Coarse-Grained Stainless Steel Using HotSense™ UT.

Inservice, UT to ensure reliable thickness data on Inservice, UT to ensure reliable thickness data on coarse-grained stainless steel.

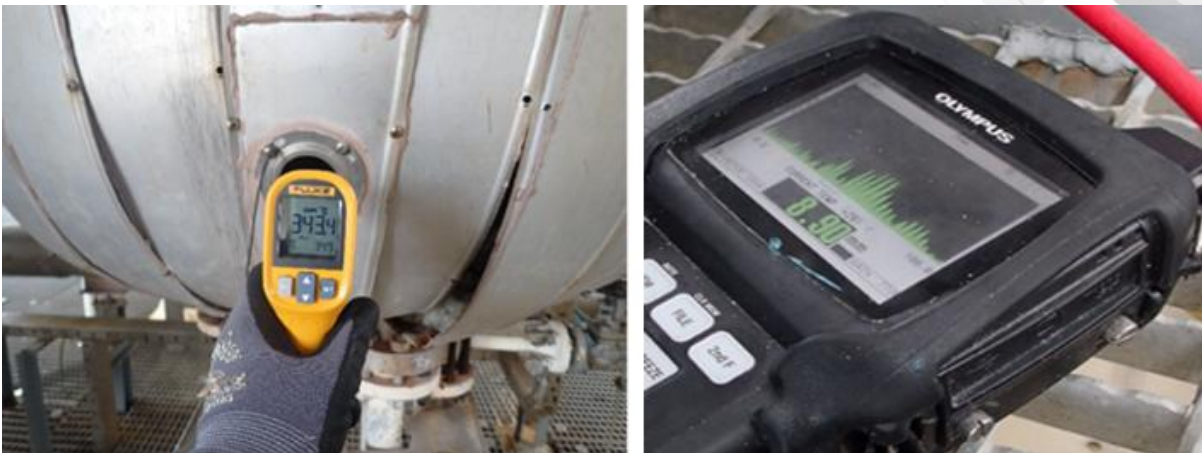
- Severe attenuation by scattering from SA240 TP321's coarse austenitic grain structure caused loss of backwall echo at 5 MHz, producing insufficient signal-to-noise ratio (SNR).
- Elevated temperature conditions (270–360 °C) further increased material damping and reduced wavelength, increasing scattering and attenuation.

Figure 1: 5 MHz probe, producing an insufficient signal-to-noise ratio.

A technical justification concluded that switching from a 5 MHz to a 2.5 MHz HS2122i HotSense™ high-temperature probe would significantly improve penetration and echo stability.

- Lower frequency (2.5 MHz) produced a longer wavelength, reducing grain scattering and restoring a stable backwall echo.
- High-temperature rating of the Ionix transducer allowed safe, continuous use up to 350 °.
- Compatibility with existing equipment allowed immediate deployment with no additional training.

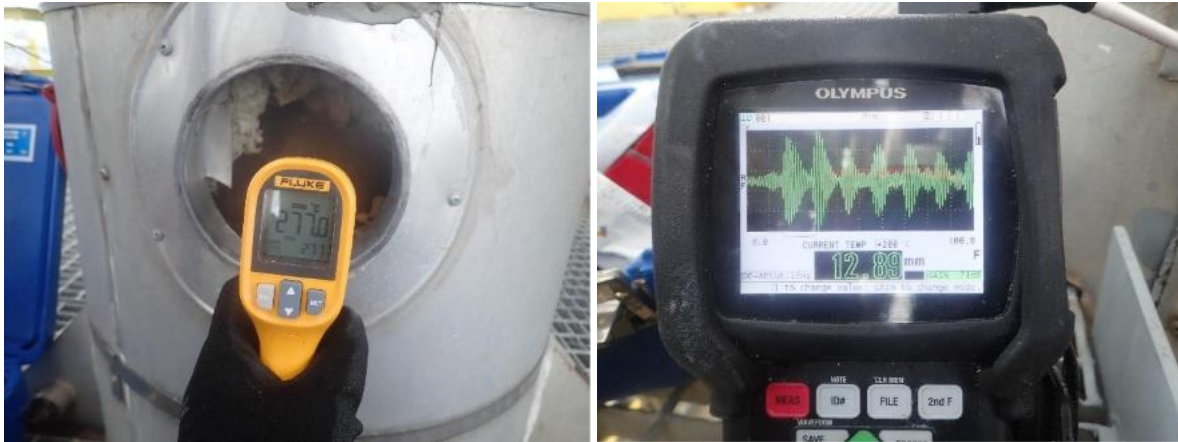
The 2.5 MHz HotSense™ probe delivered clear, consistent backwall echoes and reliable thickness readings across all inspected temperatures.

Improved amplitude and signal stability enabled measurement through the challenging TP321 material structure.

*Figure 2: Lower frequency transducer allowed accurate, repeatable in-service inspection.*
